April 9, 2021

Version 3

## Warranty Extension: 2019-20 RDX MOST Bus Network Connectors

Supersedes 21-009, dated February 18, 2021, to revise the information highlighted in yellow.

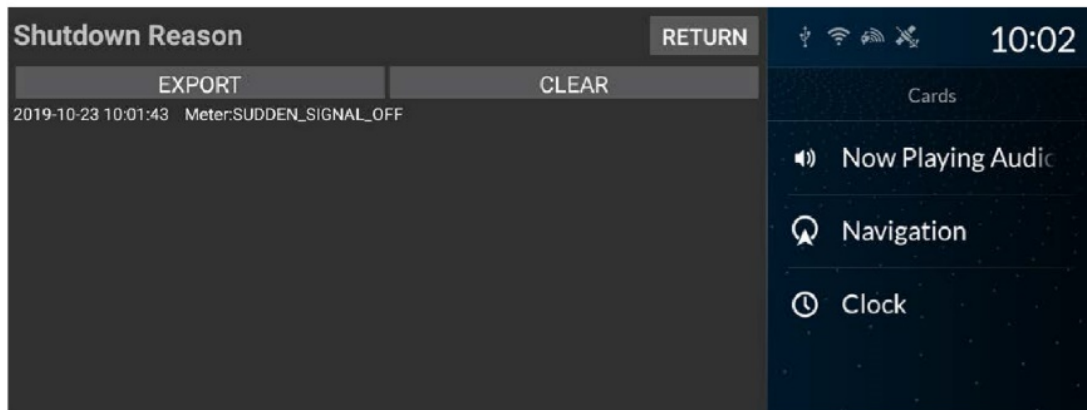
In this example, the cause of the failure can be identified as **Meter:SUDDEN\_SIGNAL\_OFF**.

5. Write down any failures as they will be collected on the warranty claim. Then, clear the data.
